PLEASANT LAKE/PARKER POND

WATERSHED CONSERVATION PROJECT

Cumberland County Soil & Water Conservation District

Prepared by Heather True
November 2011

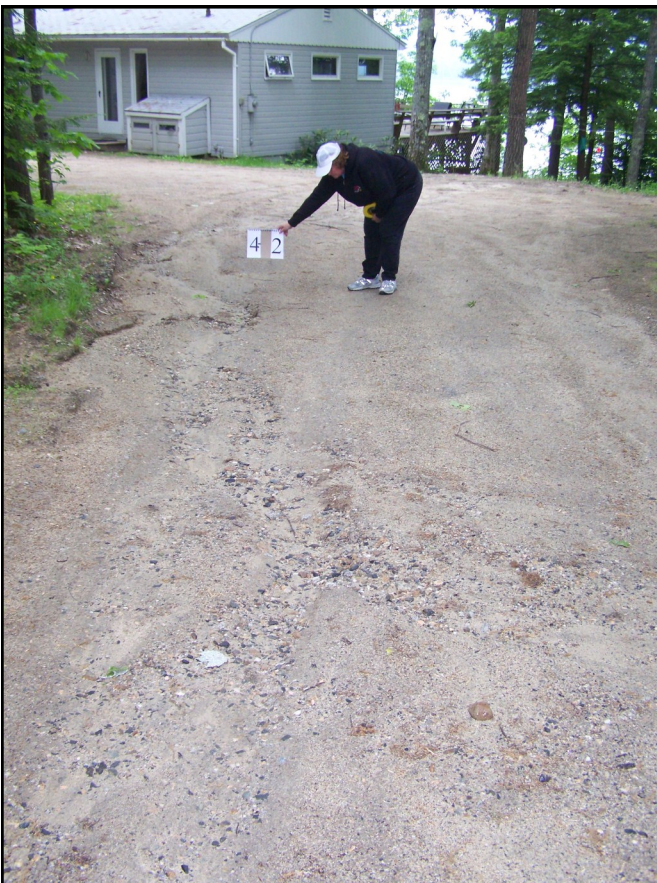
Site identified in the 2006 survey in which sediment is washing down a driveway and into Pleasant Lake.

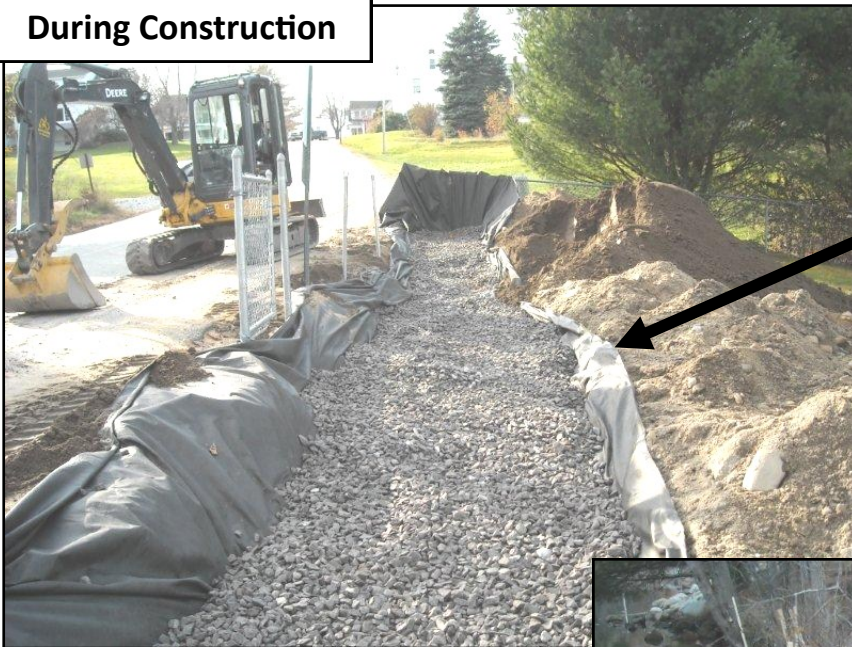
During Construction

Crushed stone infiltration trench wrapped in geotextile installed at top of beach area to absorb and infiltrate stormwater

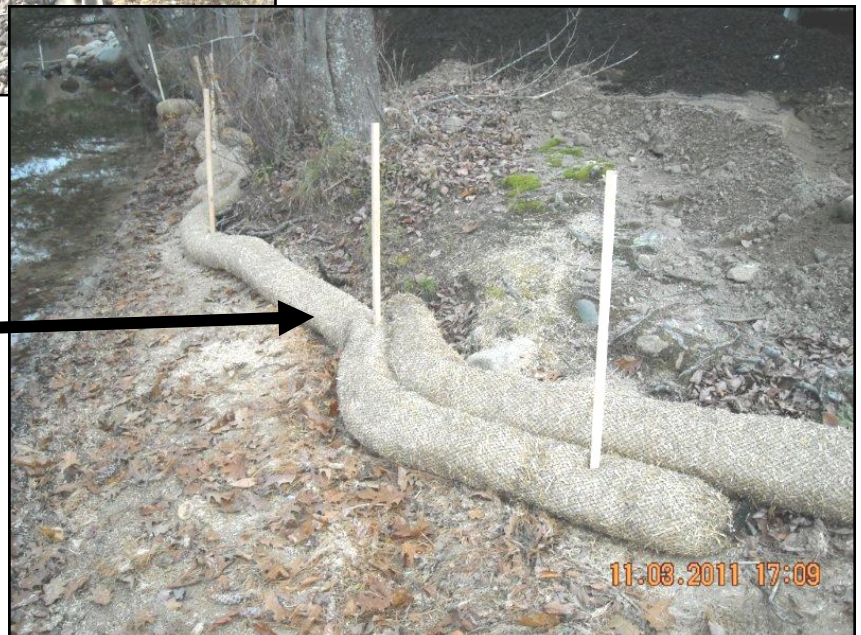
Straw wattles used to stabilize shoreline bank

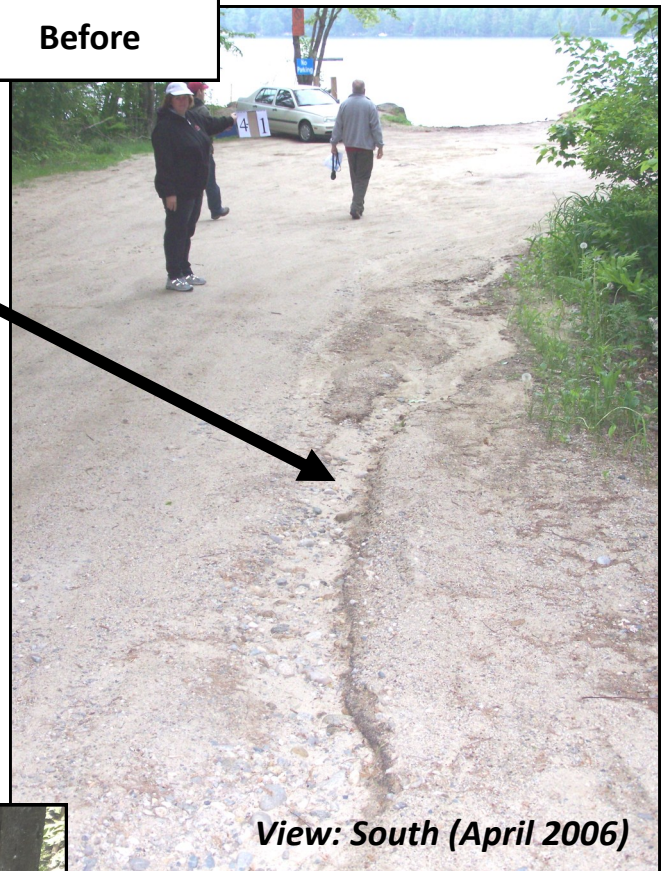
View: South (April 2006)

Erosion gully washing sediment down gravel road into Pleasant Lake

Crushed stone gravel road material added to road and road pitched to direct water into adjacent ditch

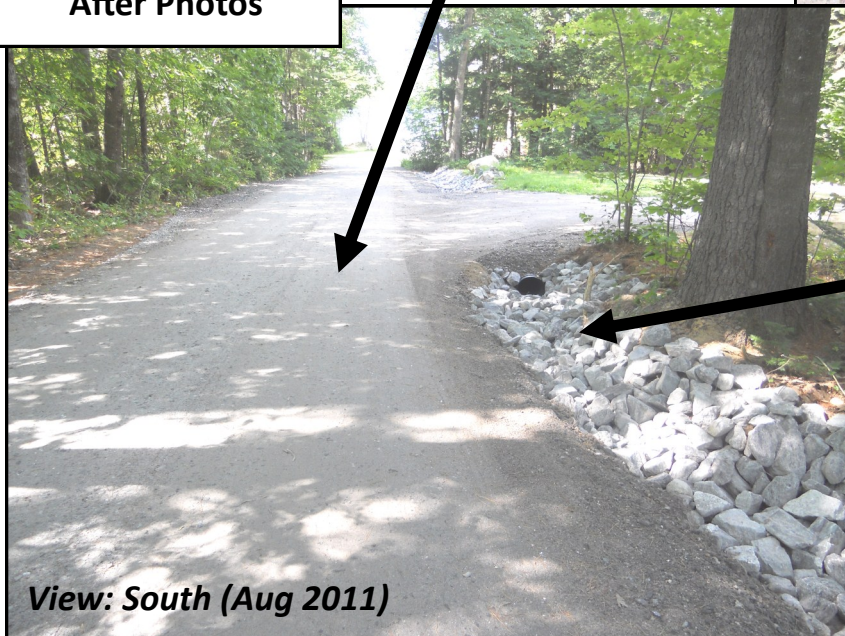
View: South (Aug 2011)

Riprap ditch leading to newly installed culvert at the top of the hill

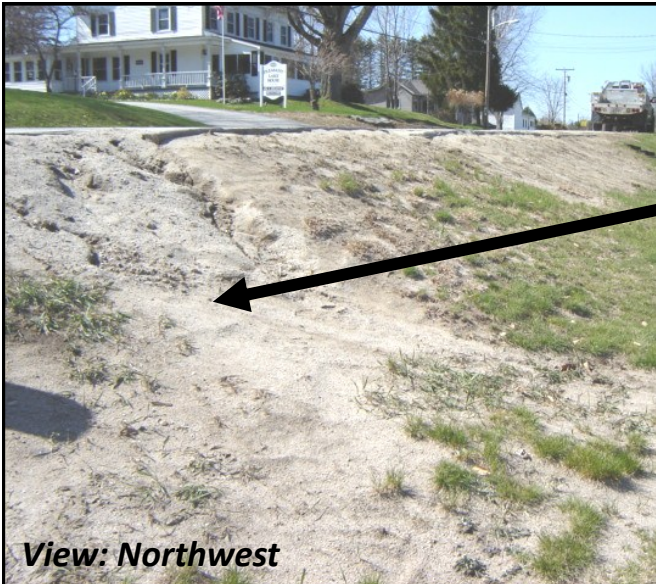
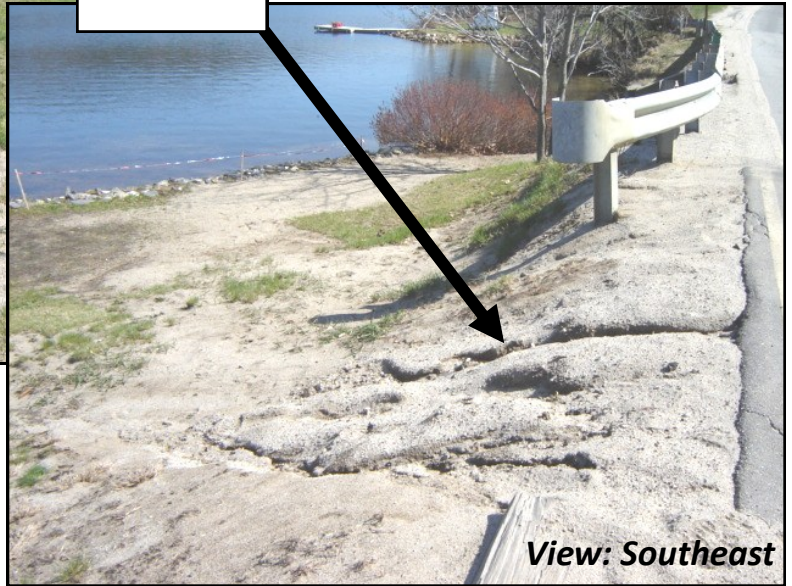
Before Photos

Erosion gullies

Paved road shoulder swale

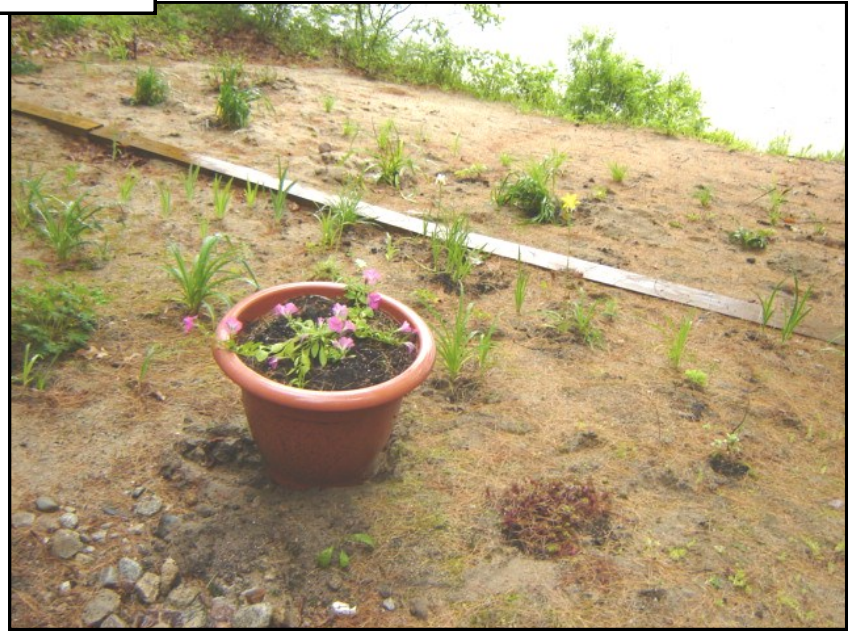
After

Planting native plants along shorelines, such as was done at this property on Lord Road in Casco, helps stabilize shoreline banks and prevent erosion.

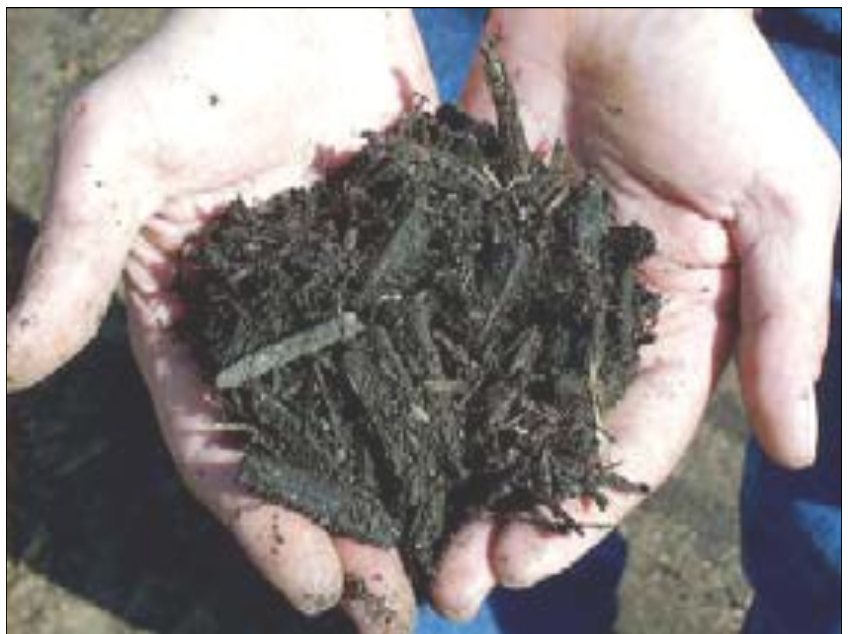
Erosion Control Mulch (ECM) is a specific kind of mulch that protects bare soil from erosion and retains moisture. ECM is made of composted bark, sand, gravel, stone, and wood fragments. It is heavier than other types of mulch and is good for walkways, recreational areas, and between plantings.

Erosion control mulch.

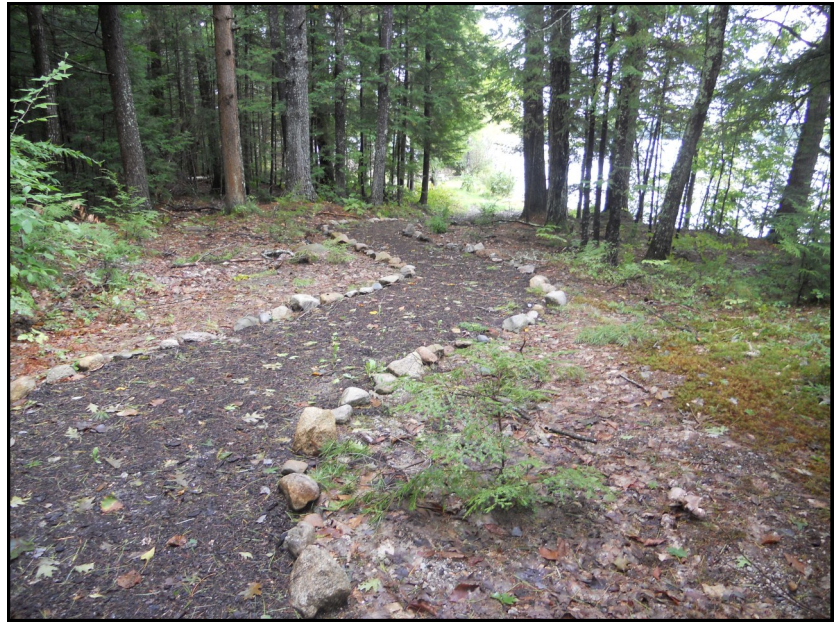
Above is a meandering pathway at Camp Arcadia in Otisfield leading to the shoreline of Pleasant Lake. Erosion control mulch, stones, and native plants were used to direct foot traffic.

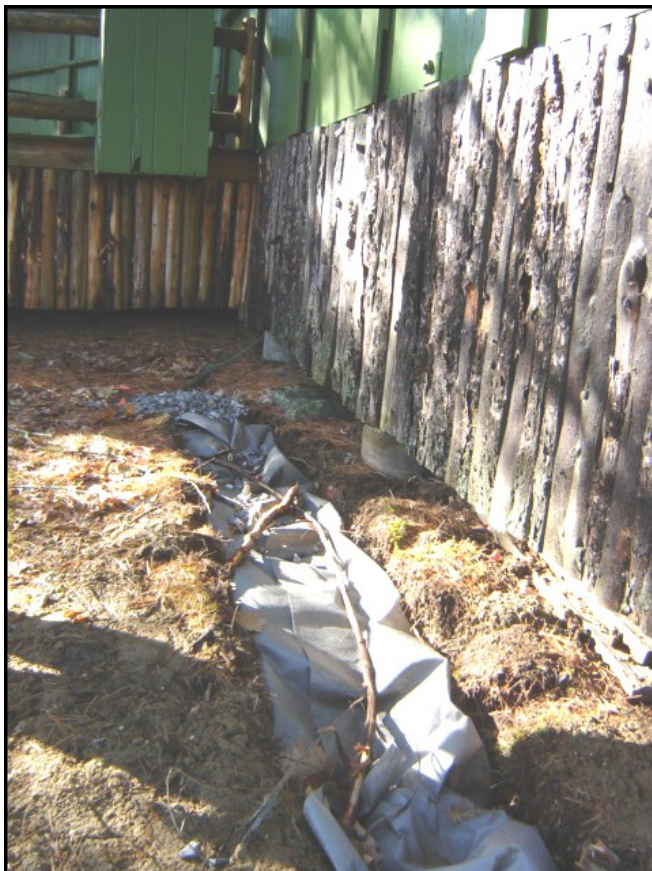
Drip line trenches collect and infiltrate rooftop runoff. Drip line trenches are typically at least 18 inches wide by 8 inches deep and are filled with 3/4 to 1.5 inch washed crushed stone.

Drip line trenches being constructed along Camp Arcadia's cabins.

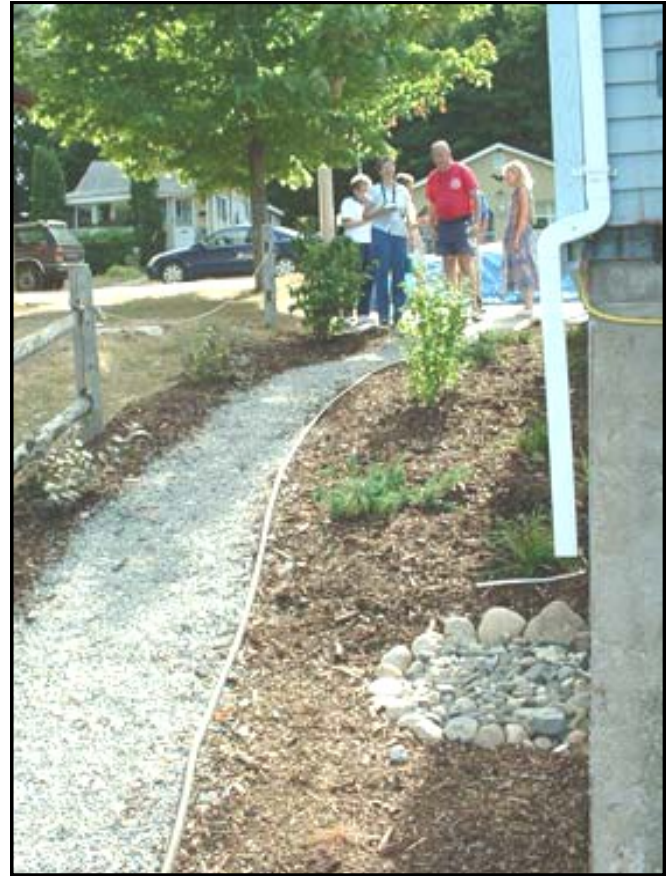
Drywells are deep reservoirs of stone used to infiltrate stormwater from roof gutter downspouts.

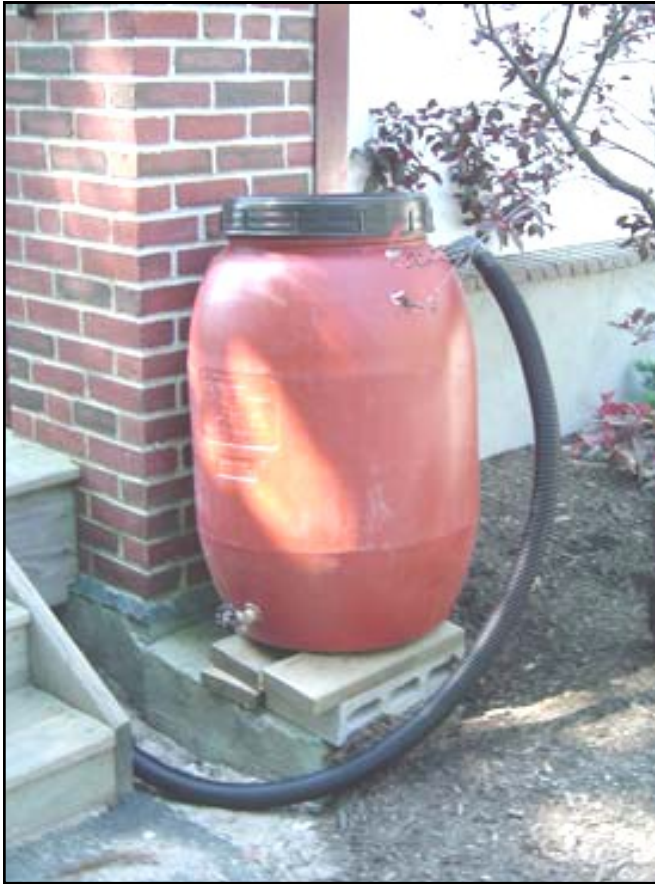
Rain barrels capture roof runoff from gutter downspouts to be used at a later time for activities such as watering gardens and flowerbeds.

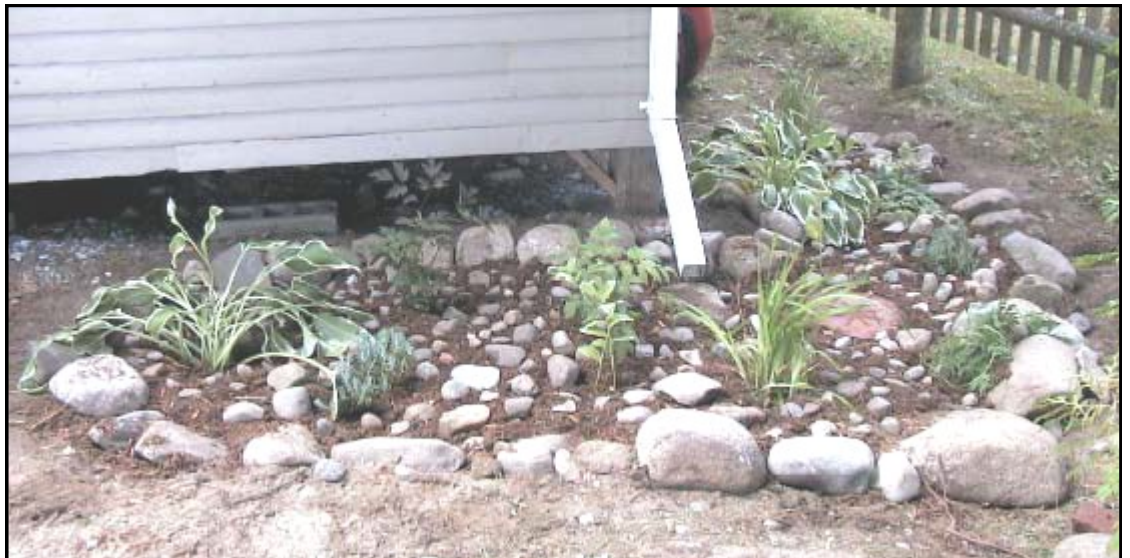
Rain gardens are bowl-shaped planted gardens that are aesthetically pleasing and allow rainwater to slowly infiltrate into the ground.

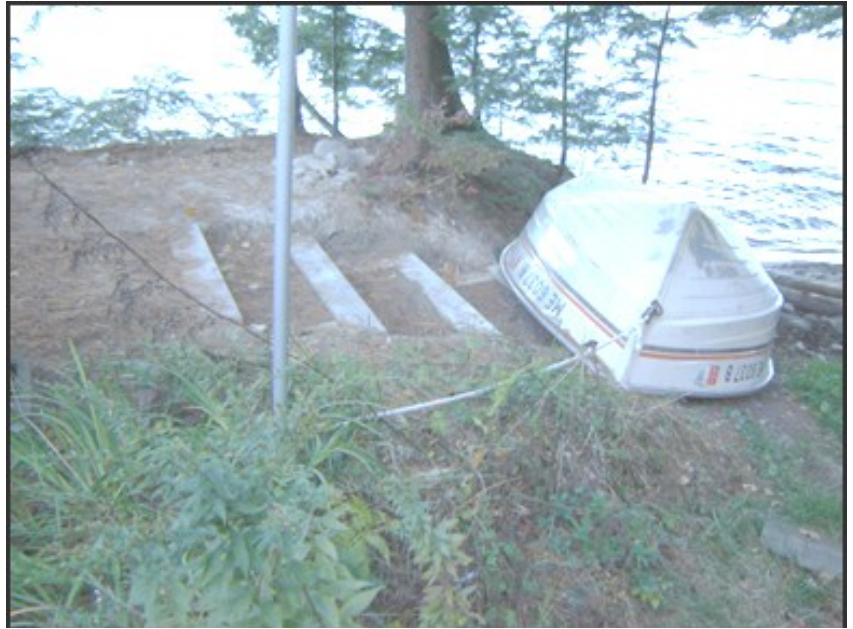
Like drip line trenches, infiltration steps use crushed stone to slow down and infiltrate runoff. Infiltration steps are typically used in walkways with moderate slopes.

Infiltration steps leading to Pleasant Lake's shoreline were created at this residential site off of Scribner Lane in Casco..

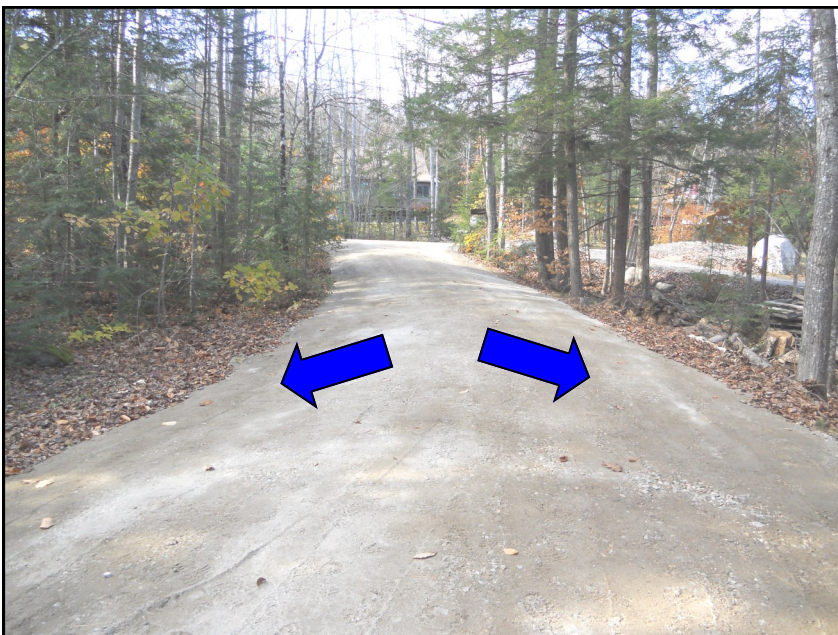
Gravel roads and driveways must drain properly to prevent water from channeling causing erosion and sediment to wash into Pleasant Lake and Parker Pond. Surface material needs to pack well, be durable, and shed water. Crowning the driveway will allow water to shed off the driveway quickly.

This driveway off of Heniger Park Road in Otisfield was recently built up, crowned and compacted to divert water into adjacent vegetation.

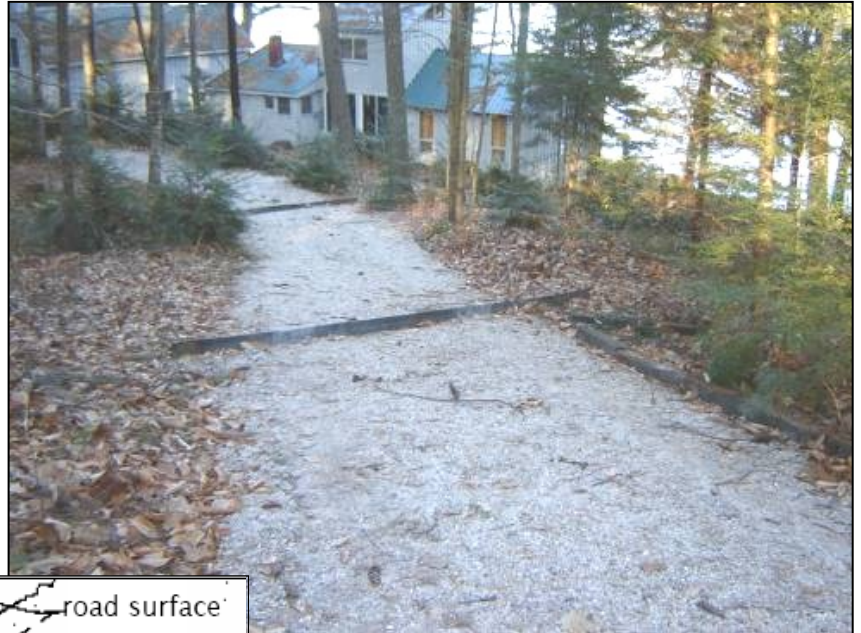
Pictured above is a series of rubber razor water diverters placed on a driveway in Denmark, Maine.

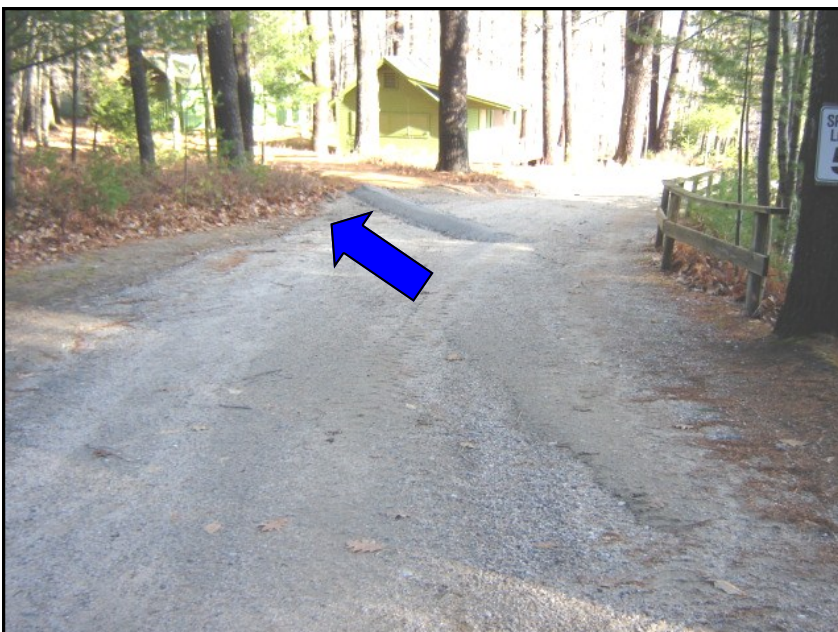
This "speed bump" water diverter was created at the top of a gravel road at Camp Arcadia to direct stormwater off the road into stable vegetation.
